Independent Tree Surveys

# Tree Survey & Planning Report

Residential Development  
Carley's Bridge  
Enniscorthy  
Co. Wexford

September 2021

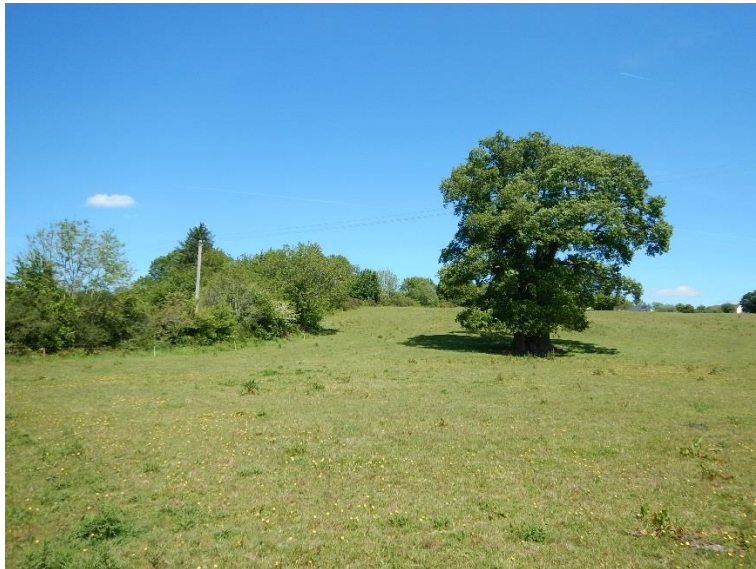
1. Oak trees T1 and T2 in field with hedge H1 to left of picture

| Type | No | Species | Age | Ht<br>m | Dbh<br>mm | St | Cr | N | S | E | W | ERC | Phys<br>Cond | Structural Condition/Comments | Preliminary Recommendations | RPA<br>m | Cat |
|---|---|---|---|---|---|---|---|---|---|---|---|---|---|---|---|---|---|
| T | 1 | Quercus robur (Common Oak) | M | 21 | 900 | 1 | 2 | 7 | 7 | 4 | 6.5 | 20+ | Fair | Fair. Large specimen tree. Asymmetric form due to competition with neighbouring tree. Minor dieback in crown. Minor deadwood in crown. Some damage to surface roots. Ivy growth on tree stem. | Crown clean to remove weak deadwood and damaged or diseased branches. Cut Ivy around stem base. | 10.8 | A2 |
| T | 2 | Quercus robur (Common Oak) | M | 21 | 1250 | 1 | 2 | 13 | 11.5 | 12.5 | 4 | 20+ | Fair | Fair. Large specimen tree. Some minor bark wounds and small decay pocket at stem base. Asymmetric crown. Minor dieback in crown. Minor deadwood in crown. Some long extended limbs. Badly damaged scaffold limb in northeast side of crown at 12m. The branch has been snapped and has a hazard beam crack extending back to branch union. Compacted root-zone. Some damage to surface roots. | Target prune broken/damaged branches. Prune to reduce length and weight of extended branches. | 15 | A2 |

The embankment supporting the proposed new access road will encroach across the root protection areas (RPA) of the mature Oak trees labelled T1, T2 and T3. Successful long-term retention of these trees will require that the new bank and road is constructed using methodology that ensures that the new road is supported by a properly engineered base structure (such as a Cellular Confinement System (CCS)) that will prevent excessive soil compaction and allow infiltration of water and gases into the soil within the RPAs of the trees. These products may need to be built up in more than one layer depending on the precise level changes and load requirements of the new road. The base of the slope of the embankment should be kept set back from the base and root flare of the trees, with the trees themselves protected from direct damage by sturdy fencing. The hard surfacing of the new road and footpaths passing through the RPAs should be of a permeable nature.

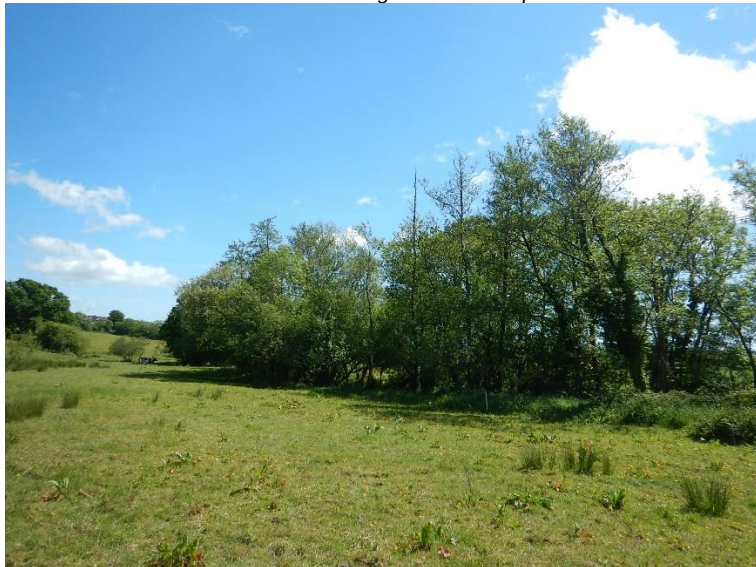
2. Riparian tree group G3 along riverbank

| Type | No | Species | Age | Ht<br>m | Dbh<br>mm | St | Cr | N | S | E | W | ERC | Phys<br>Cond | Structural Condition/Comments | Preliminary Recommendations | RPA<br>m | Cat |
|---|---|---|---|---|---|---|---|---|---|---|---|---|---|---|---|---|---|
| G | 3 | Alnus glutinosa (Common Alder)<br>Salix spp. (Willow)<br>Fraxinus excelsior (Ash)<br>Crataegus monogyna (Hawthorn)<br>Prunus spinosa (Blackthorn)<br>Sambucus nigra (Elder) | M | 6<br>to<br>12 | 100 to<br>400 | | | | | | | 10+ | Fair/Poor | Fair. Narrow riparian woodland strip along riverbank following the south western boundary of site. Mostly made up of Alder and Willow. Many Alder suffering dieback (probably caused by Phytophthora spp.), with several fallen stems and standing dead. | Coppic weaker stools/stems to encourage fresh growth. Infill gaps with fresh planting.<br>Monitor condition of Ash trees to track progress of Ash Dieback disease. | 4.8 | C2 |

The tree-lines growing along the bank of the River Urrin (groups G3 and G4) will be less exposed to demolition or construction damage, but will require protection none-the-less.

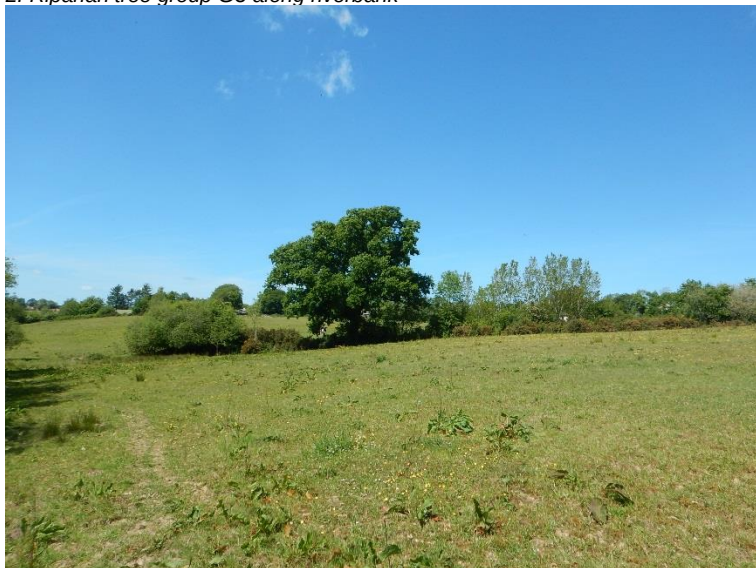
3. Hedge H2 with large Oak tree T3

| Type | No | Species | Age | Ht<br>m | Dbh<br>mm | St | Cr | N | S | E | W | ERC | Phys<br>Cond | Structural Condition/Comments | Preliminary Recommendations | RPA<br>m | Cat |
|---|---|---|---|---|---|---|---|---|---|---|---|---|---|---|---|---|---|
| T | 3 | Quercus robur (Common Oak) | M | 19 | 1100 | 1 | 3 | 11 | 12 | 11.5 | 11 | 40+ | Good | Fair. Large specimen tree growing on edge of ditch. Good shape/form. Some previous root damage possible. Minor deadwood in crown. Historic storm damage. Some long extended limbs. | No urgent works needed. Crown clean to remove weak deadwood and damaged or diseased branches. | 13.2 | A2 |

The variable ground levels and proximity of the proposed works to Oak tree T3, mean that this tree will be extremely vulnerable to root loss/damage during the development works and will require particular care and supervision to reduce any negative impact on the tree. Direct arborist supervision of the works around this tree will be necessary to ensure that root damage is kept to a minimum.

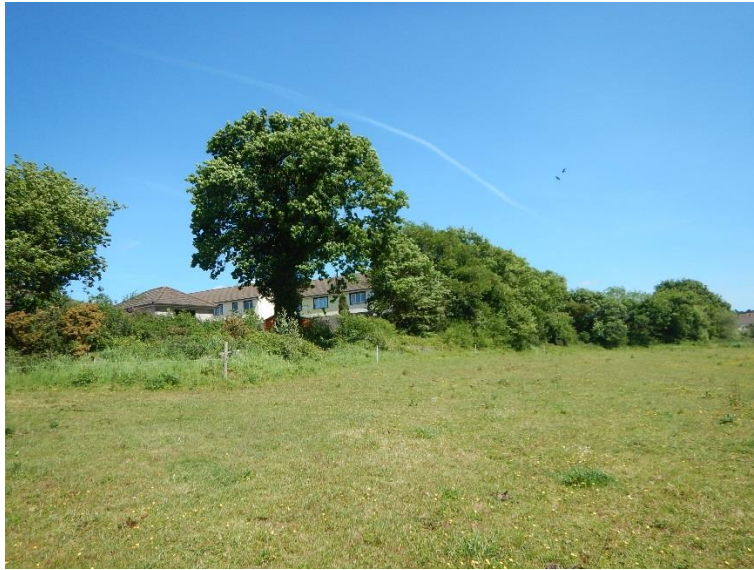
4. Tree group G1 with larger Oak tree T20 bordering adjacent garden

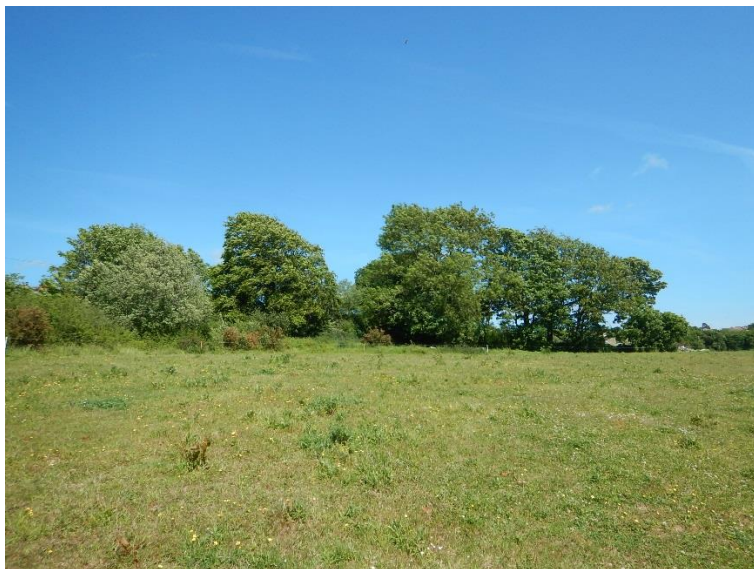
5. Trees T6-T11 beside the old outbuildings

| Type | No | Species | Age | Ht<br>m | Dbh<br>mm | St | Cr | N | S | E | W | ERC | Phys<br>Cond | Structural Condition/Comments | Preliminary Recommendations | RPA<br>m | Cat |
|---|---|---|---|---|---|---|---|---|---|---|---|---|---|---|---|---|---|
| T | 7 | Fraxinus excelsior (Ash) | M | 15 | 636 | 2 | 2.5 | 8 | 8 | 7.5 | 7 | 20+ | Fair | Fair. Medium sized tree. Twin stem from ground level. Tree is growing out of old wall and bank by old outbuilding. | Monitor tree condition for signs of Ash Dieback disease. | 7.63 | B2 |
| T | 8 | Acer pseudoplatanus (Sycamore) | M | 12 | 750 | 1 | 1.5 | 5 | 4 | 7 | 6 | 10+ | Fair | Poor. Medium sized tree. Tree growing out of old wall next to old shed. Decay in old wounds at 1m north side and at 2m of main stem. Some bark wounds to lower stem, probably by livestock. | No urgent works needed under current land usage. Not suited to retention within new development. | 9 | C2 |
| T | 9 | Fagus sylvatica (Beech) | M | 15 | 600 | 1 | 2.5 | 4 | 5 | 6 | 5 | <10 | Poor | Poor. Medium sized tree. Average shape/form. Major bark wounding on stem by livestock. Indications of internal decay column from Thor hammer. Dieback in crown. Some sparseness of upper crown. | No urgent works needed under current land usage. Not suited to retention within new development. | 7.2 | U |

| Type | No | Species | Age | Ht<br>m | Dbh<br>mm | St | Cr | N | S | E | W | ERC | Phys<br>Cond | Structural Condition/Comments | Preliminary Recommendations | RPA<br>m | Cat |
|---|---|---|---|---|---|---|---|---|---|---|---|---|---|---|---|---|---|
| T | 10 | Acer pseudoplatanus (Sycamore) | EM | 11 | 541 | 2 | 0 | 3 | 5 | 6 | 5 | 10+ | Poor | Fair. Low vitality. Growing on edge of ditch. Smaller sized tree. Some damage to surface roots. Large surface roots. Asymmetric form due to group competition. Dieback in crown. | No urgent works needed. | 6.49 | C2 |

The short line of trees (labelled T5-T11) next to the old work yard in the northern part of the site will need to be removed to facilitate the new development; this will include the Beech tree labelled T6 if it proves impractical to retain a substantial section of the old stone wall out of which the tree is growing. The roadside hedge H1 (including tree T42) will require removal to create the sightlines necessary to allow safe access to and from the site and to allow for the construction of the new boundary walls.

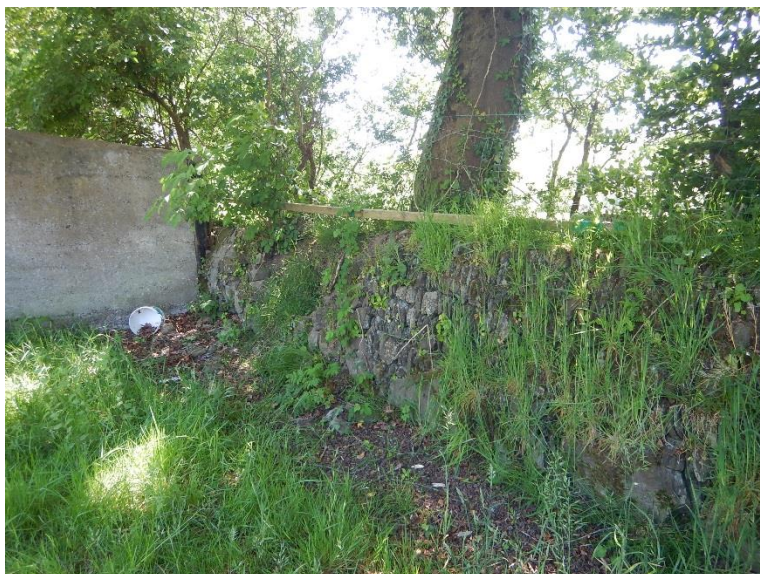
6. Base of beech tree T6 growing out of old stone and earth bank/wall
